## Evaluation of Construction Quality Problems of Ujung Berung Transit Apartment Flat Building in Bandung City

Aprilia Dwi Rahmawati<sup>1\*</sup>, Sri Pare Eni<sup>2</sup>, Posma SJK Hutasoit<sup>3</sup>  
Universitas Kristen Indonesia

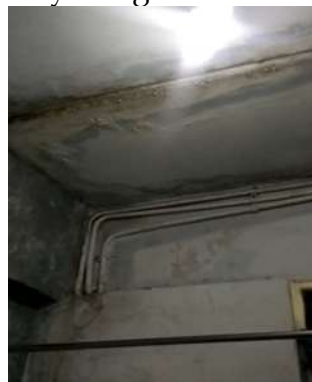
Field observations revealed various construction problems at the Ujung Berung Transit Apartment. Cracks were visible on interior walls and corridors, indicating possible material aging, structural fatigue, or insufficient reinforcement during initial construction. In addition, signs of moisture and local leaks were found on the ceiling and wall corners, indicating an inadequate waterproofing system and suboptimal roof drainage. This physical damage reduces the durability of the building and directly affects the comfort level of the residents.

Several units also showed damage to the finish, such as peeling paint, damp wall surfaces, and corrosion on metal components. This pattern of damage indicates that maintenance has been limited or irregular, in line with the building's operational age of nearly a decade. These findings reflect the general condition of low-cost public housing, where construction quality and long-term management are often limited by budget availability.

**Figure. 4 Cracks in the Bathroom Area**

absence of vertical mobility facilities such as elevators, causing significant constraints for elderly residents and individuals with mobility challenges. Based on these conditions, this study recommends a comprehensive structural audit and targeted repairs, enhancement of fire protection facilities, upgrading of electrical systems, improvement of ventilation and lighting performance, expansion of wastewater and solid-waste handling capacity, strengthened building accessibility, and the implementation of a scheduled preventive maintenance program. These interventions are essential to ensure regulatory compliance, extend building lifespan, and improve overall housing quality in government-provided rental facilities.

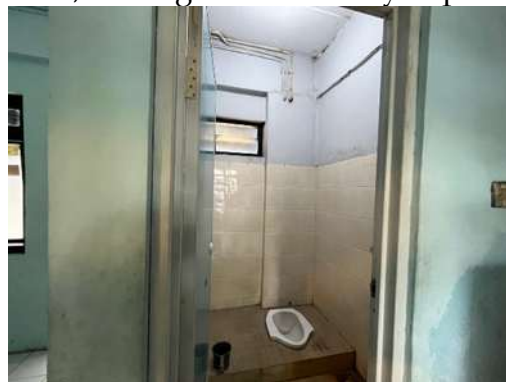
Several units had minimal openings, resulting in inadequate natural ventilation, poor air circulation, and elevated indoor humidity. Mechanical ventilation was rarely used, leaving residents fully dependent on natural airflow.

**Figure 5. Humidity of the Bathroom Area**

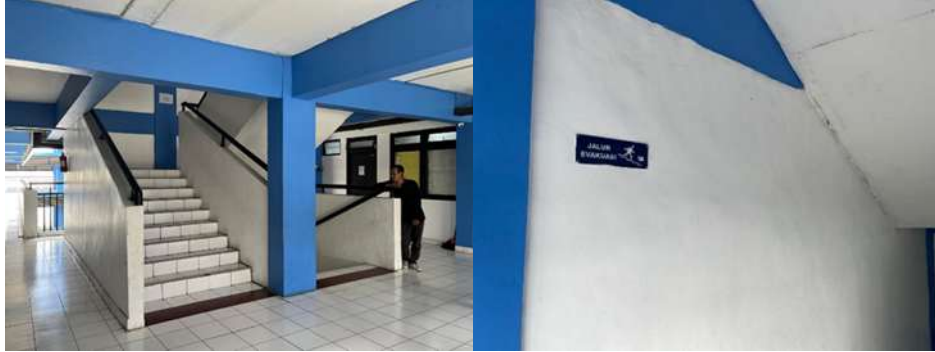
Horizontal circulation—corridors and staircases—was functional but experienced congestion during peak hours. Vertical circulation relied entirely on staircases due to the absence of elevators, posing challenges for elderly residents, people with disabilities, and those carrying heavy loads.

**Figure 6. Building Access**

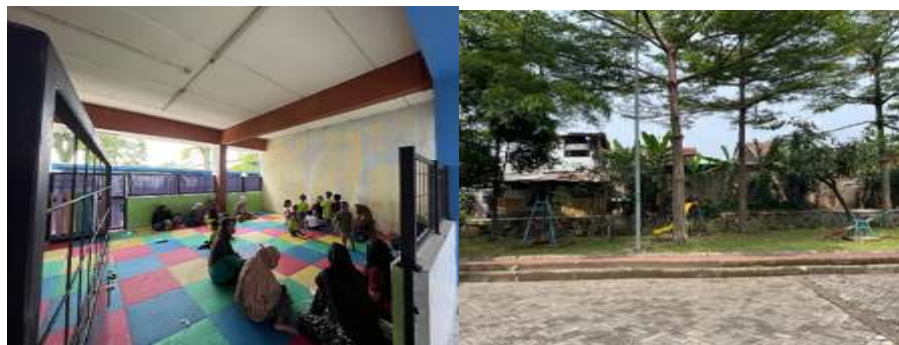
Public facilities such as prayer rooms, play areas, and open spaces were available but showed signs of wear.

**Figure 7. Play Areas and Learning Areas**
